NASA Contractor Report 181945

**DEVELOPMENT AND FABRICATION OF STRUCTURAL
COMPONENTS FOR A SCRAMJET ENGINE**

**Contract NAS1-16097
March 1990**

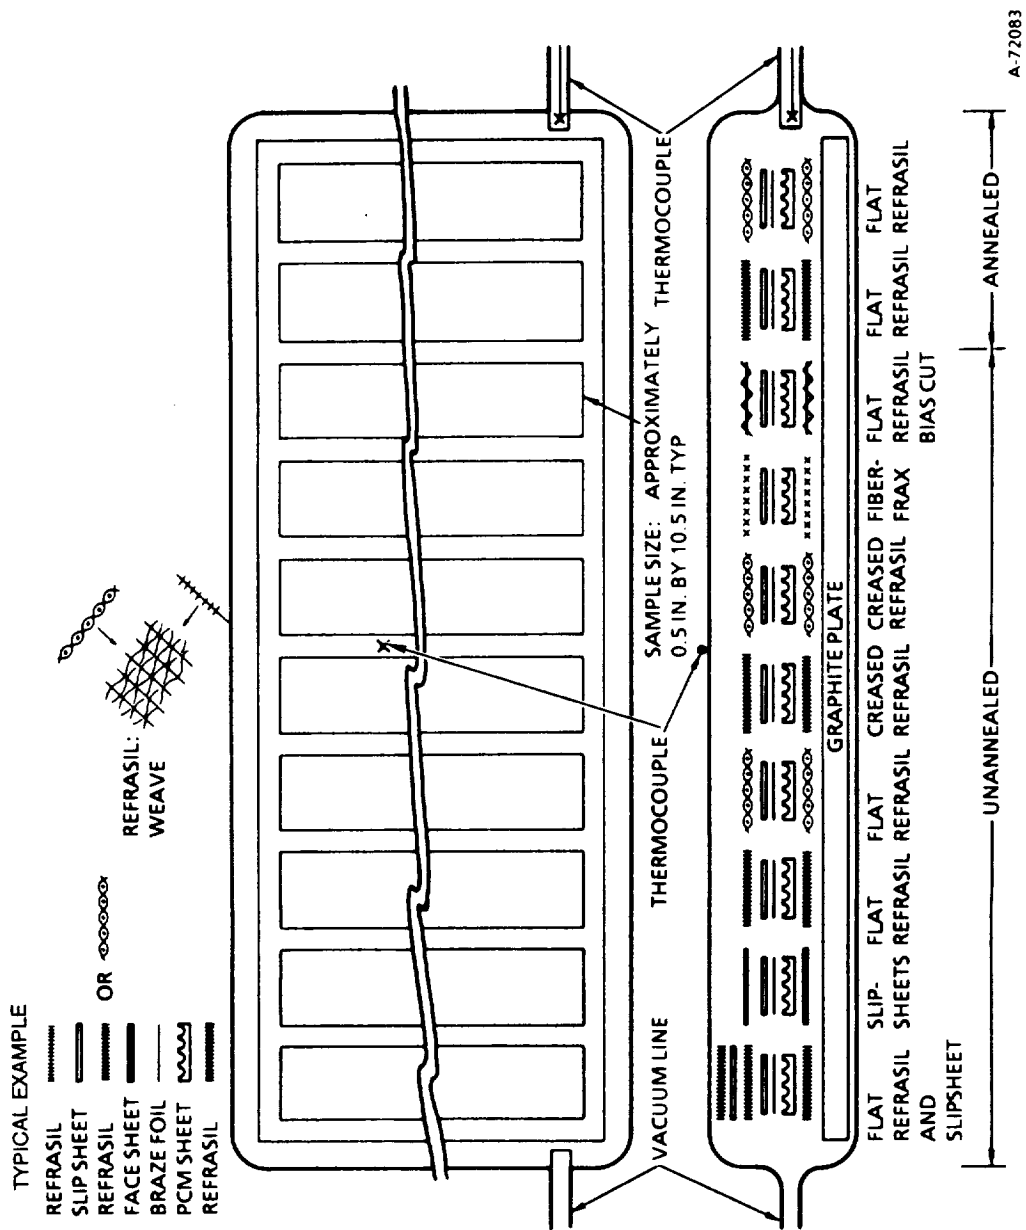
Figure 120. Setup for Braze Shrinkage Investigation with Multiple Test Samples

A PL forward jacket assembly was then brazed using the modified cycle, and the shrinkage reoccurred. Examination of the Refrasil cloth, a high-temperature fiber material used in the braze setup (Figure 116), indicated shrinkage of the cloth. This effect was not previously observed. Because of this unexpected shrinkage in the PL jacket and cloth, a sixth series of test samples was tested using the modified temperature and pressure histories. These samples incorporated various Refrasil

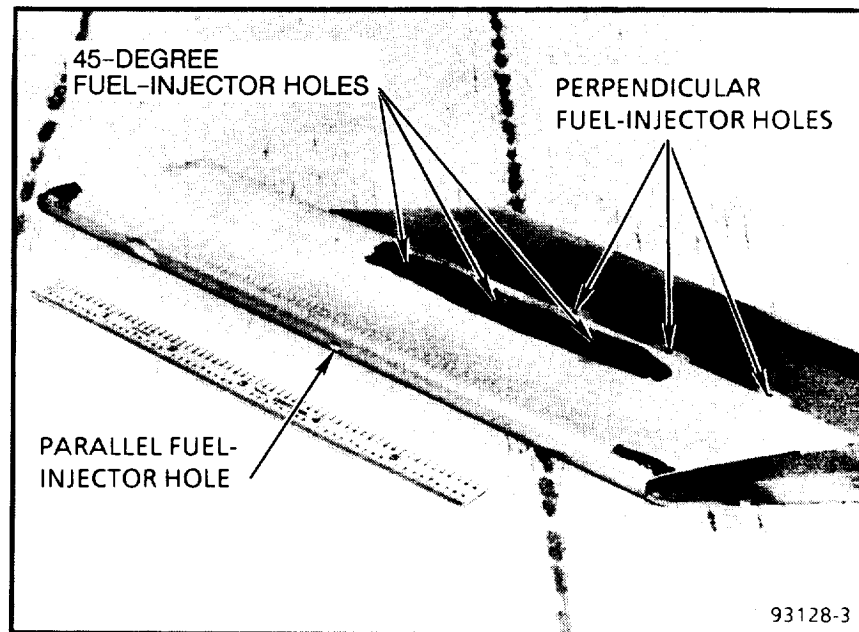
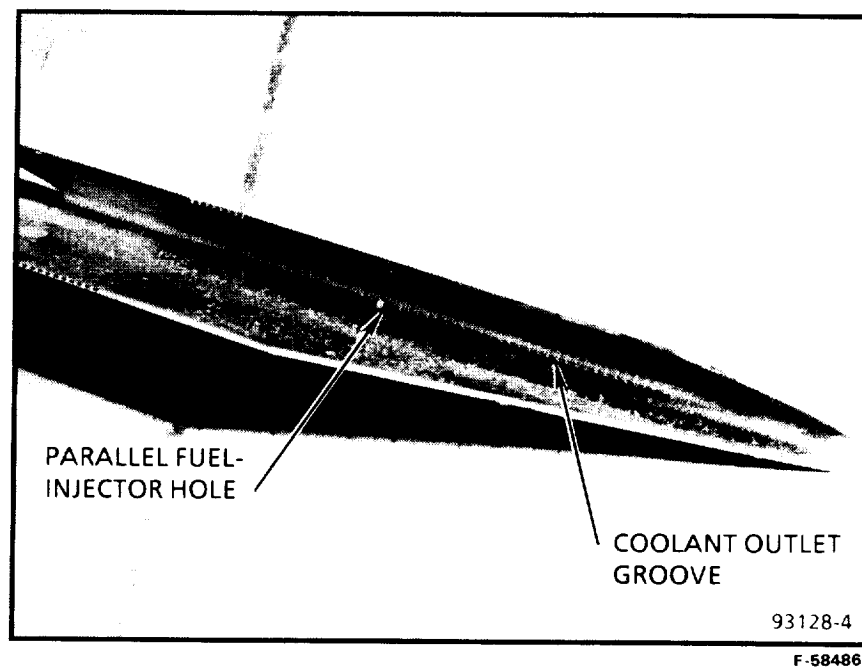
Figure 123. Formed Partial Length Aft Cooling Jacket (PL1)

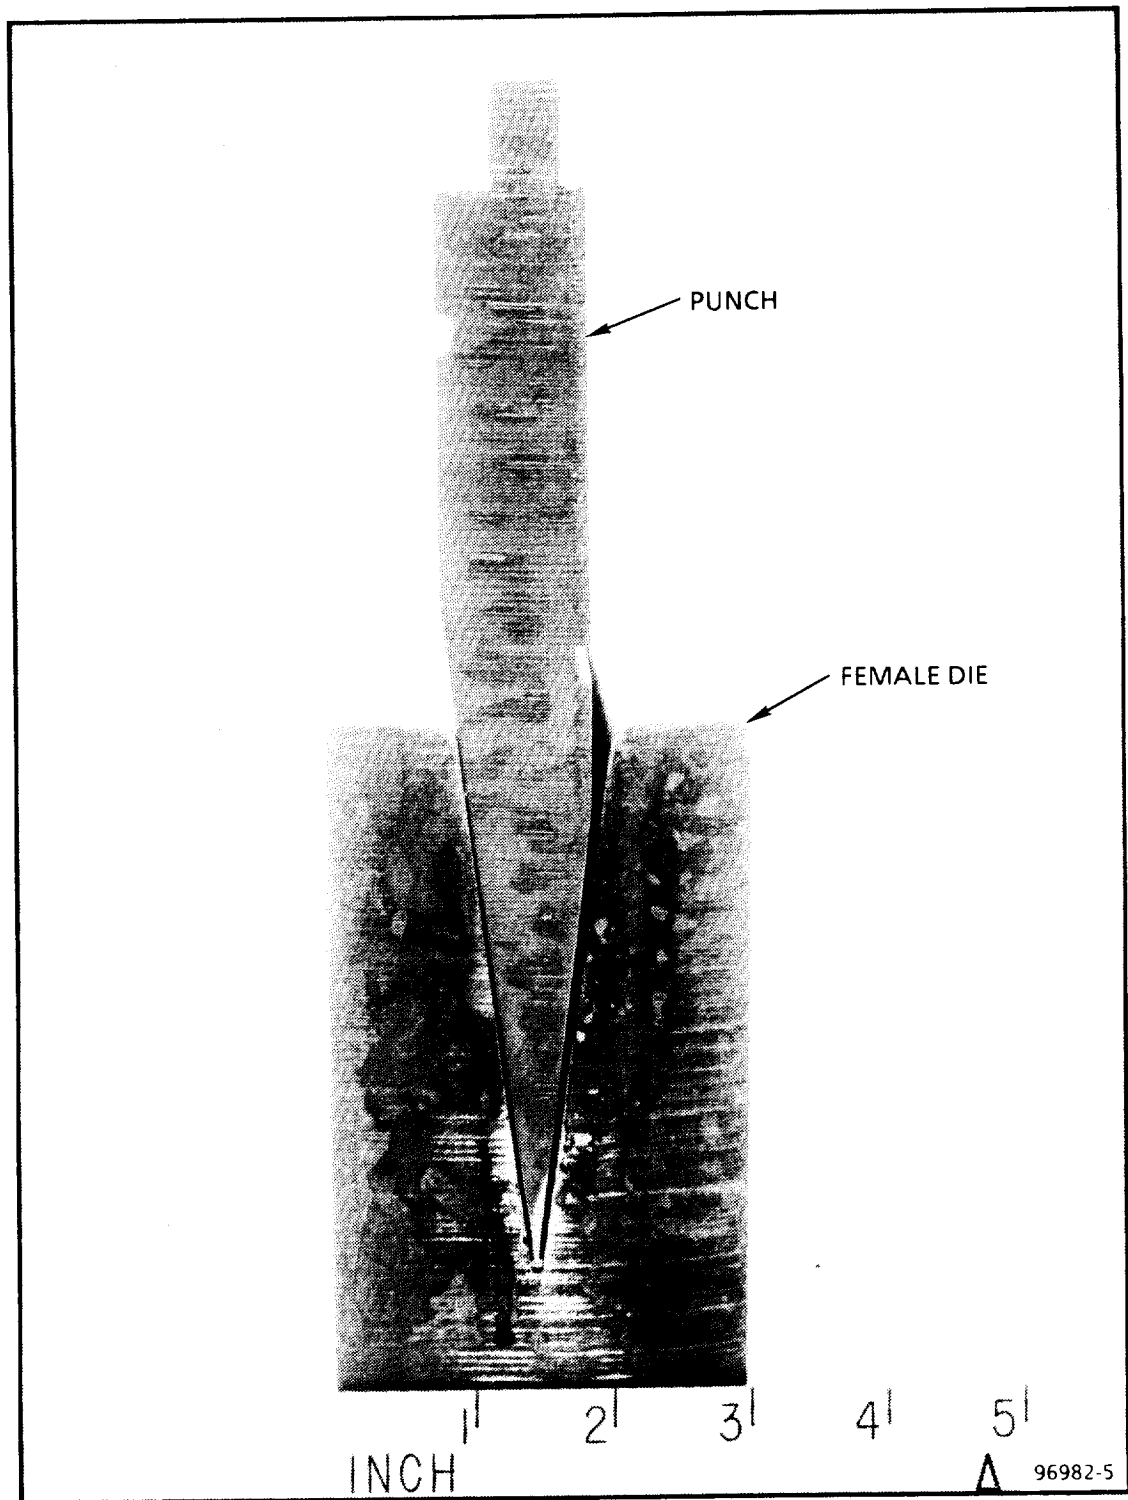
Figure 137. Jacket Leading Edge Coining Tool

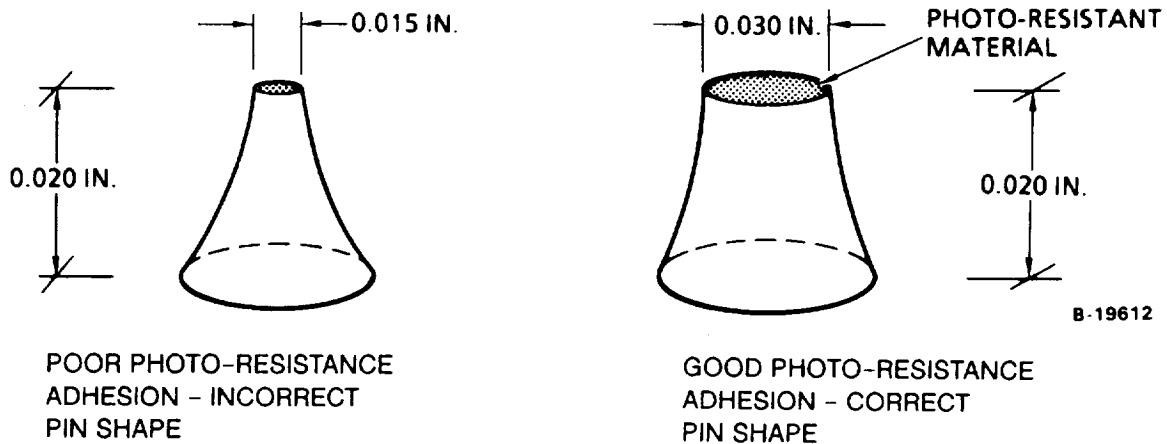
Figure 138. Effect of Loss of Photo-Resistant Materials on Pin-Fin Tips

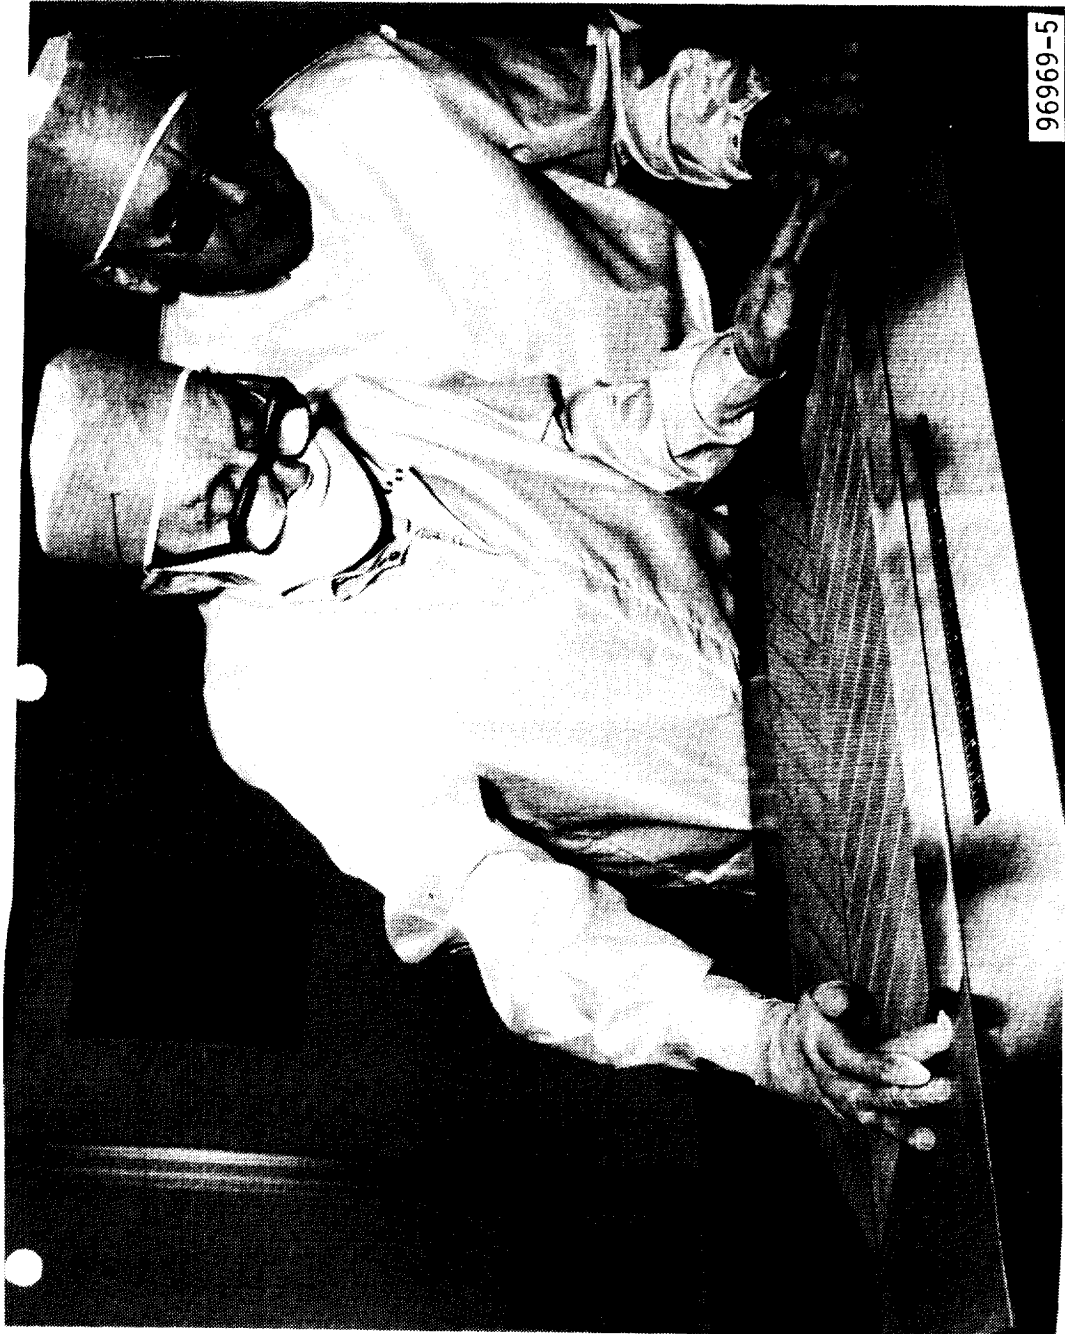
Figure 142. Application of Braze Foil During Stacking of the Forward Jacket for Brazing

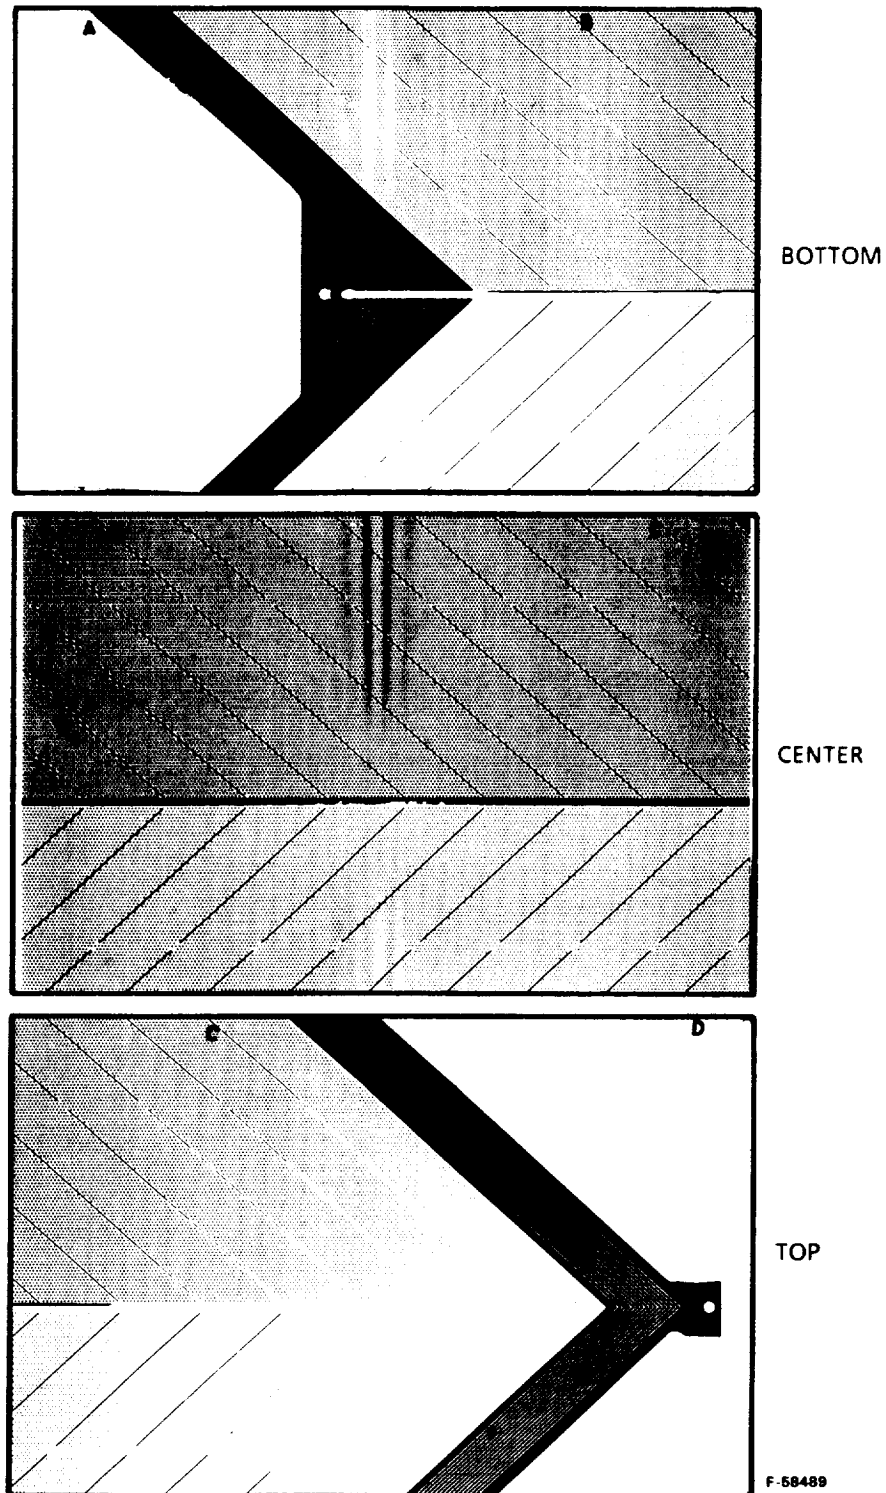
Figure 143. X-Ray of Brazed Full-Length Forward Coolant Jacket

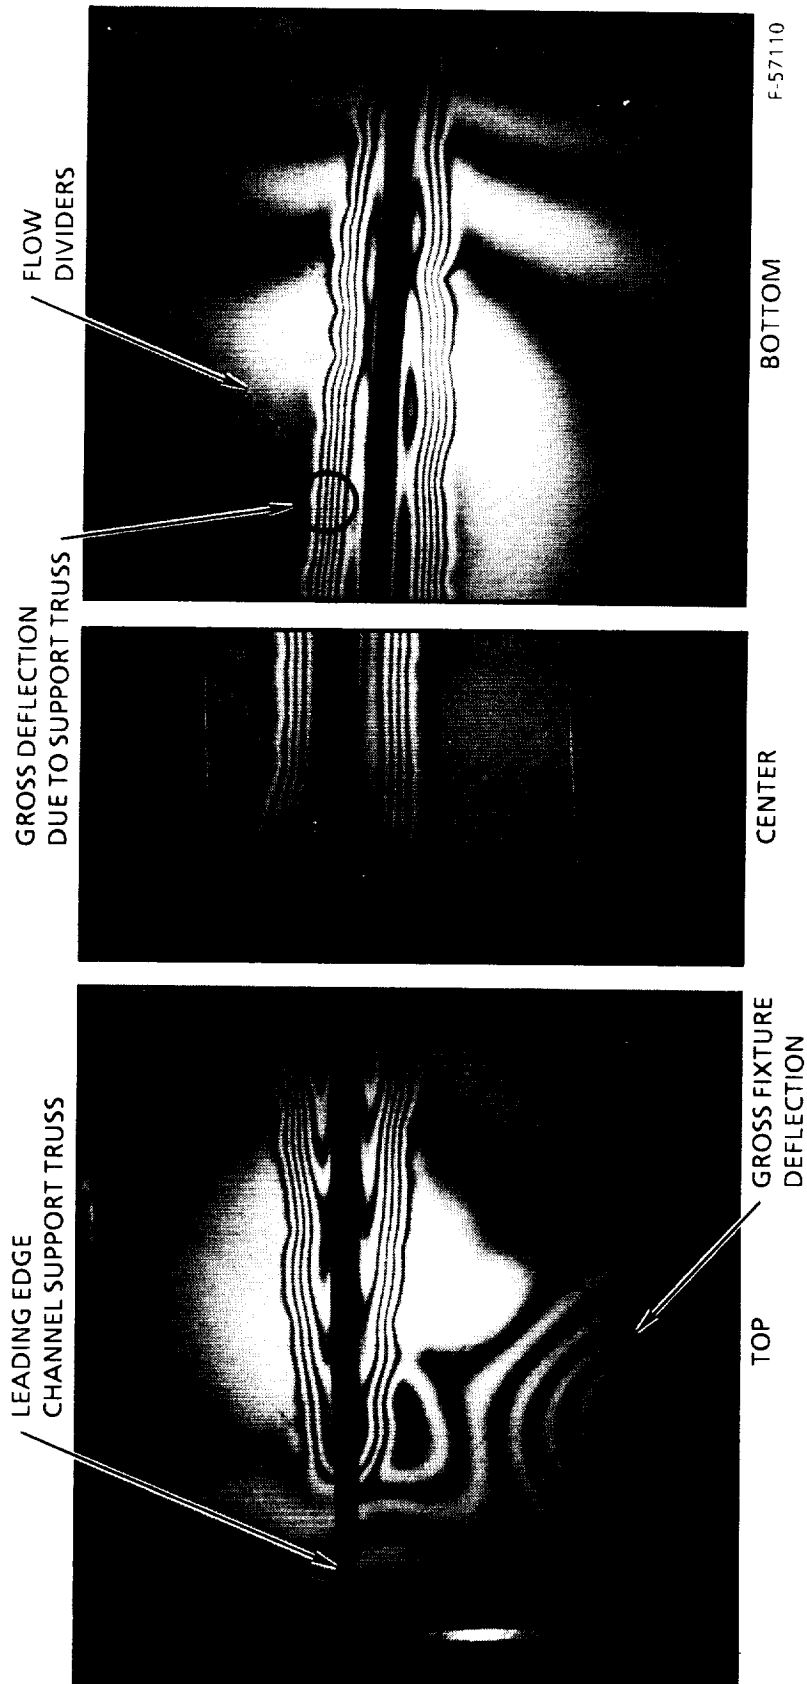
Figure 145. Brazed Forward Jacket Hologram after 1050-psig
Proof Pressure, at 840 psig and 40 psid. No
Indication of Braze Voids

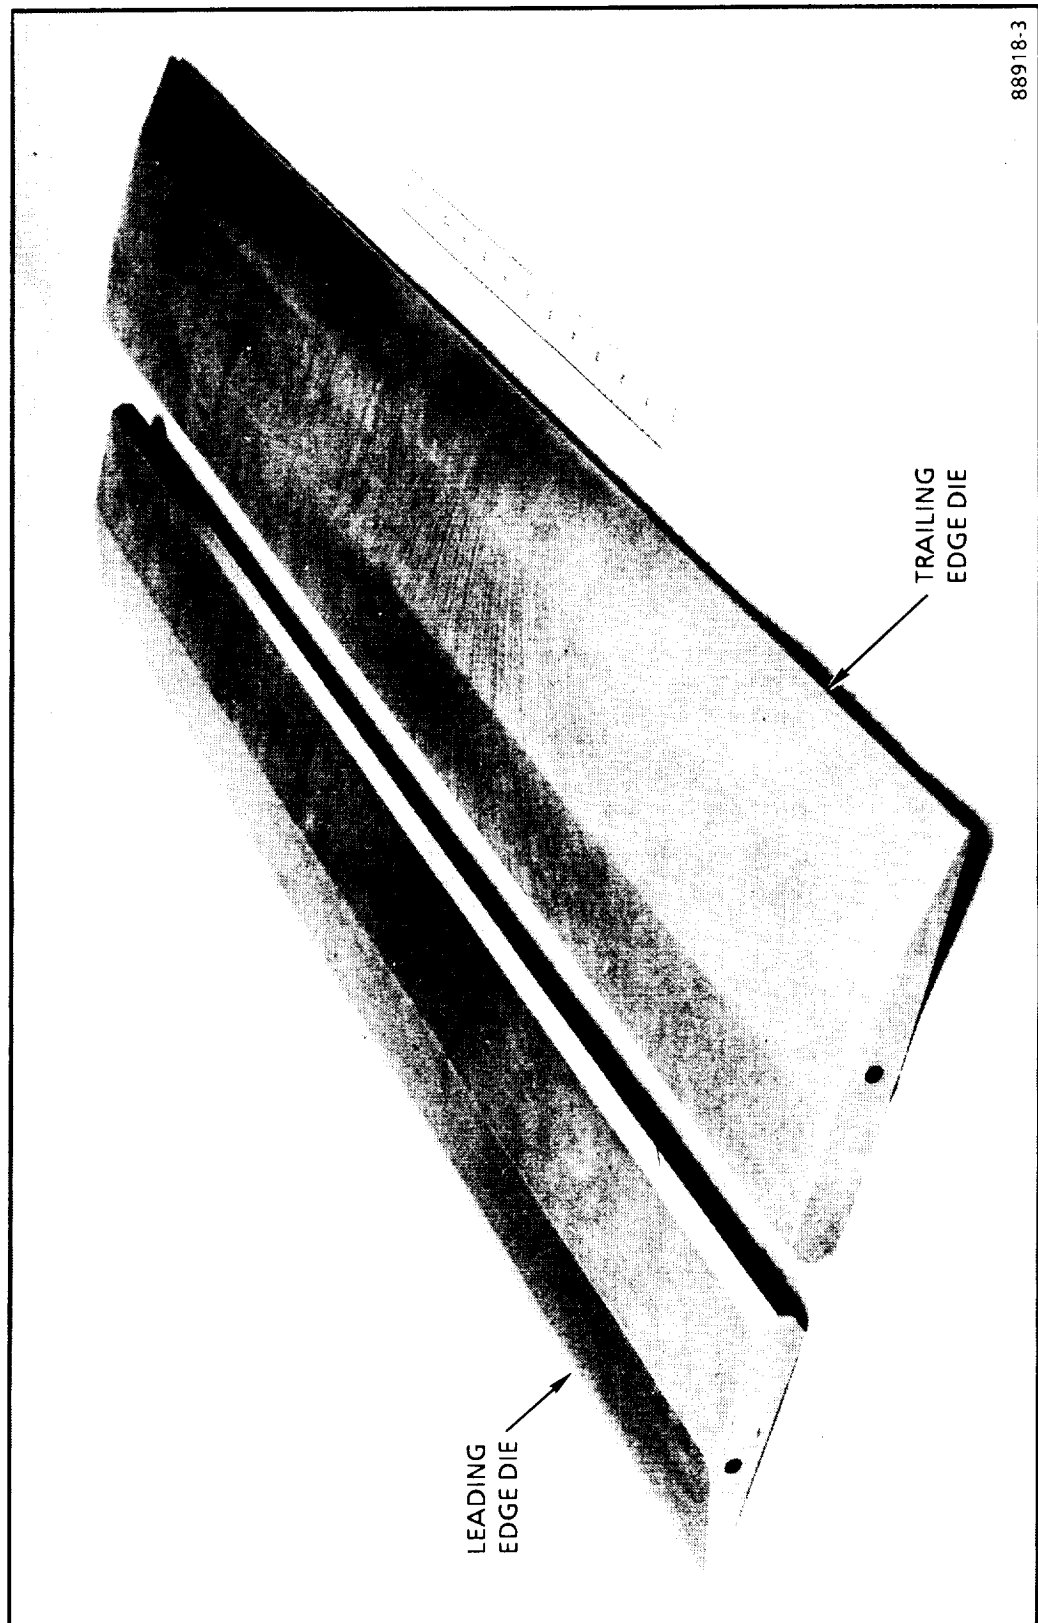
Figure 153. Inconel 718 Hot-Sizing Dies for Full-Length Strut Support Structure Sections

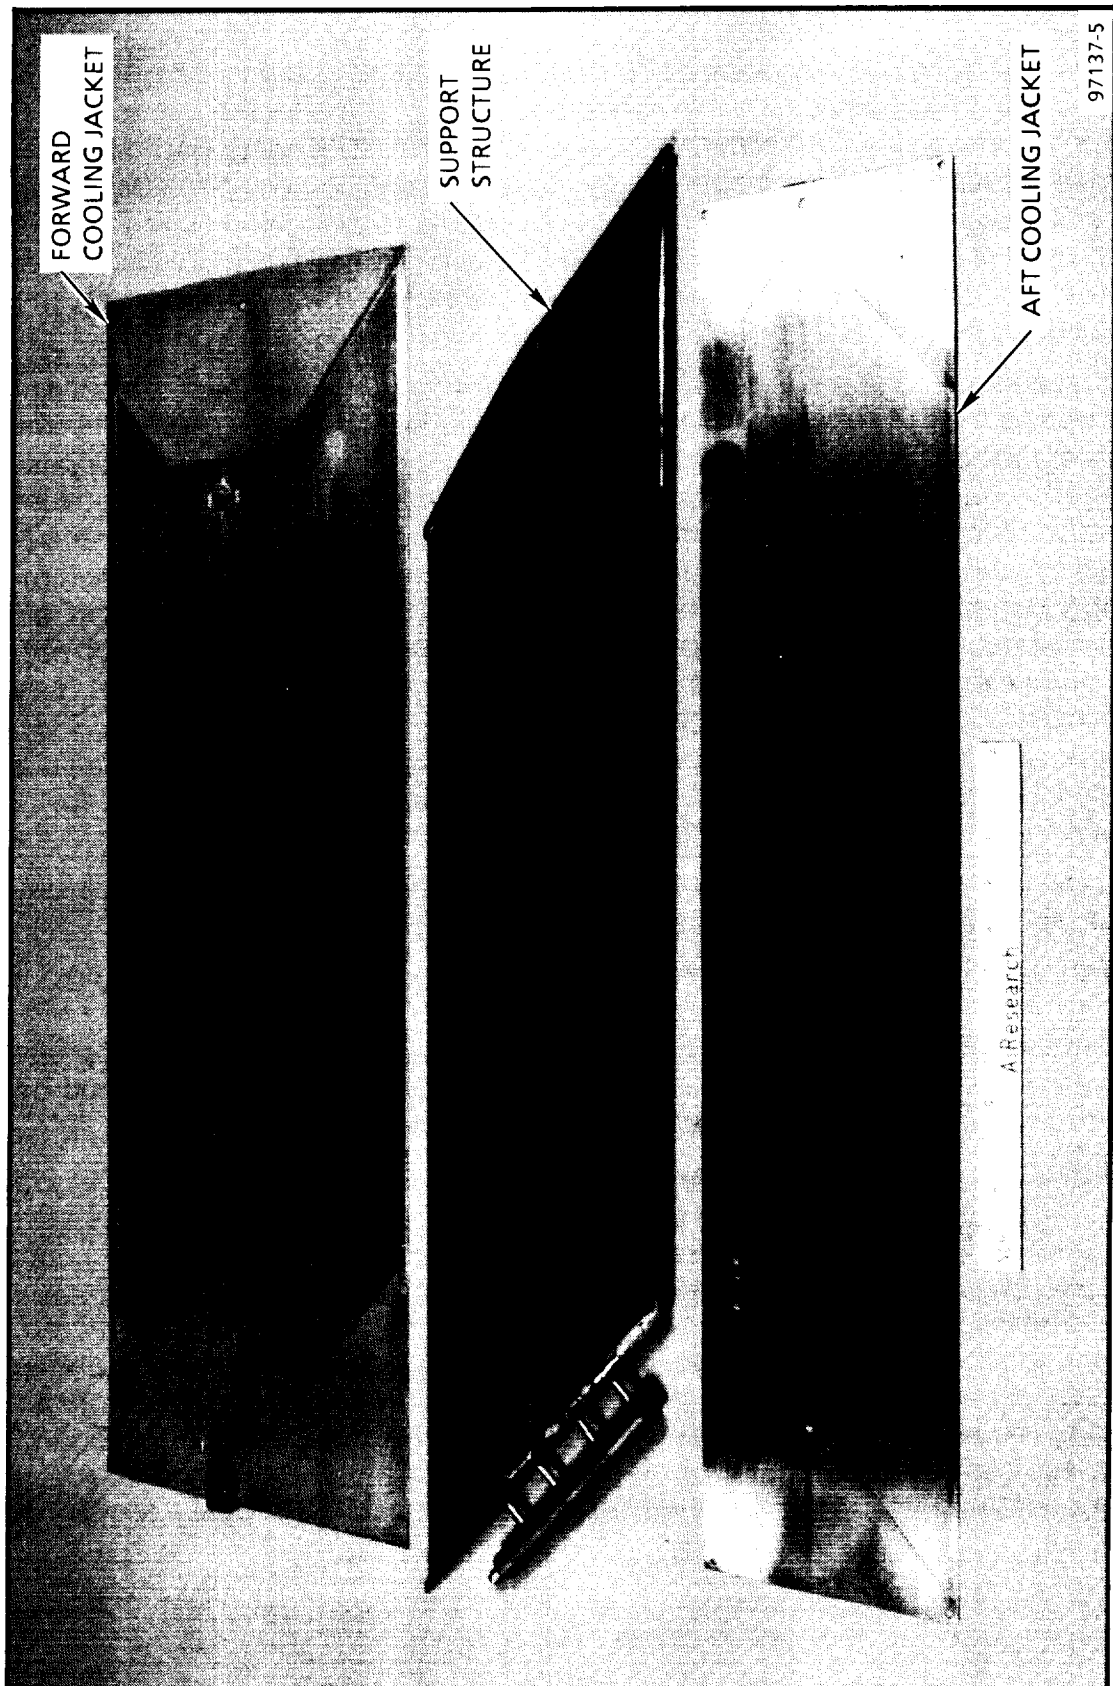
Figure 167. Completed Full-Length Strut Subassemblies
